Is a lumen really cleaned if you can't see down it?

Marija Juraja, Andrew Ellis
Infection Prevention & Control Unit, Central Sterile Supply Department
Central Adelaide Local Health Network

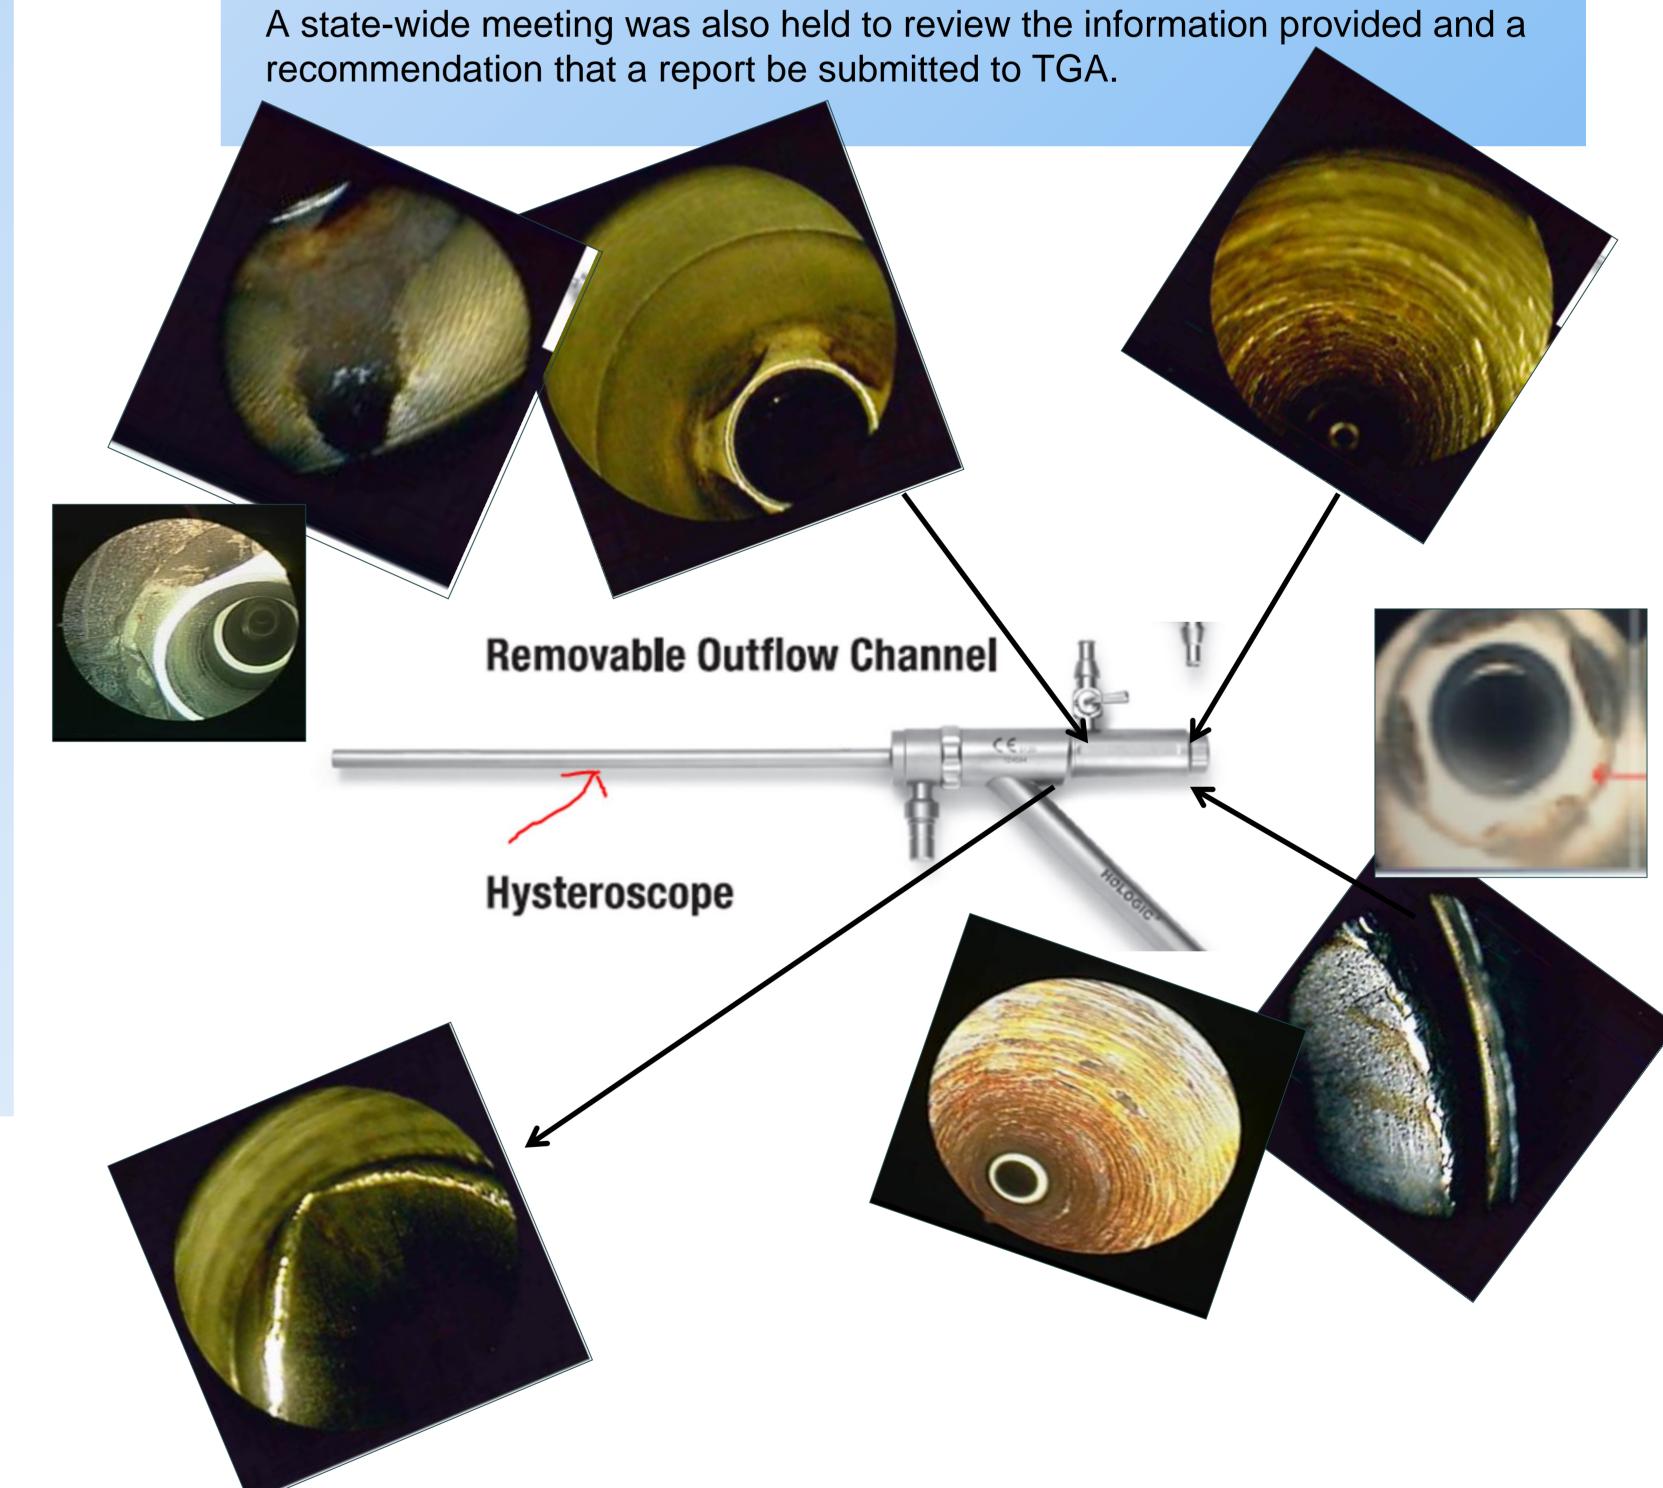
different hospital and with their findings (refer to pictures 1-6) found that the ridges and voids within the scope made the scope difficult to clean. Of particular concern was the rust build up found in some of the scopes, with some scopes less than six months old and in continuous use. On further investigation the scopes had varying issues from an internal polished shaft, a distal tip window that was calcified, rust and foreign particles found within the channel.

The state made a decision that the device removed from use and replaced with an sourced product. As well you can see the media was engaged.

This highlighted how important our CSSD services are in cleaning and reprocessing devices. It gave us challenges and opened up debate about solid scope designs. It highlighted that we should be undertaking randomised visual inspections of these scopes to validate the cleaning process. This should be included in any assessment of a new scope prior to implementation or even well before this in the design phase.
